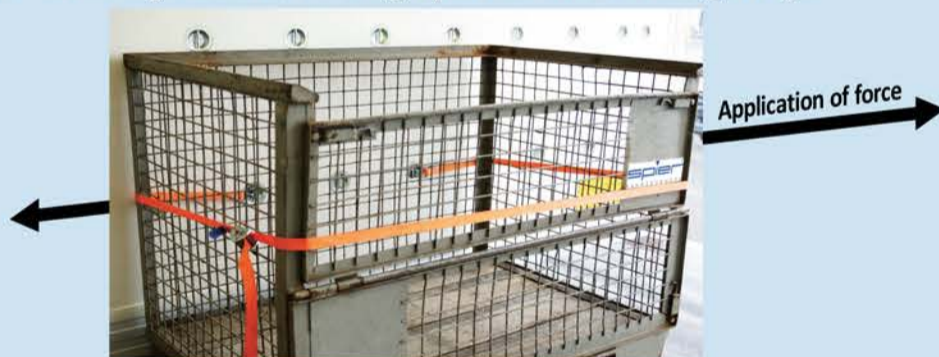
4. Securing loads to lashing systems with lashing straps

Attention: If the lashing system is overloaded, high forces will abruptly be released. This is an accident hazard.
